Inspection Photos

I00090053+07232

Location 10 KM E SUPERIOR Stucture Name: none

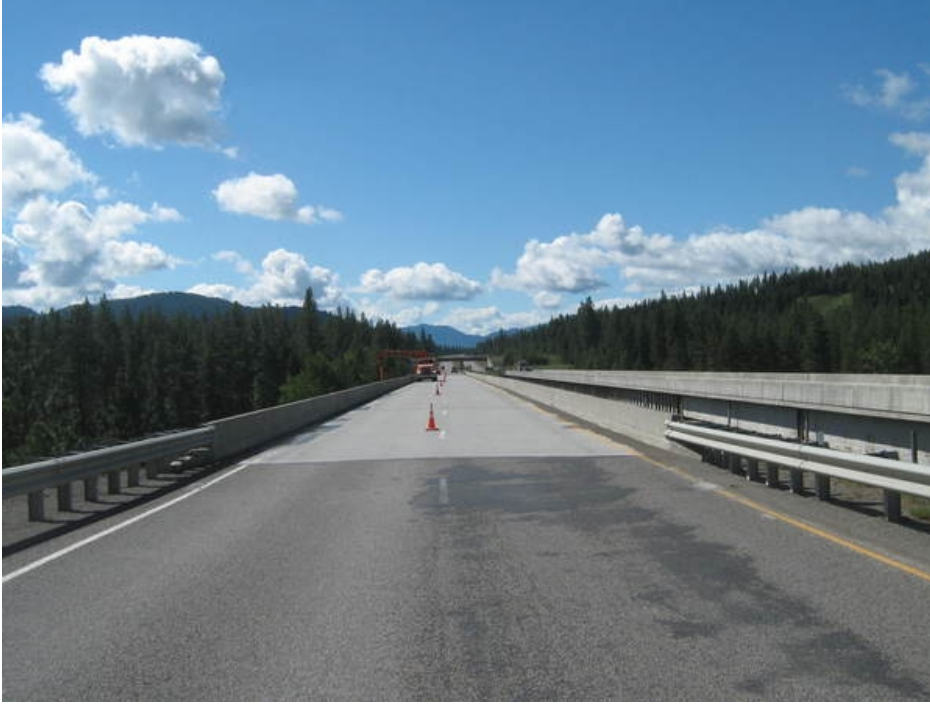
AOL **Notes**

Looking east, flow is from left to right.

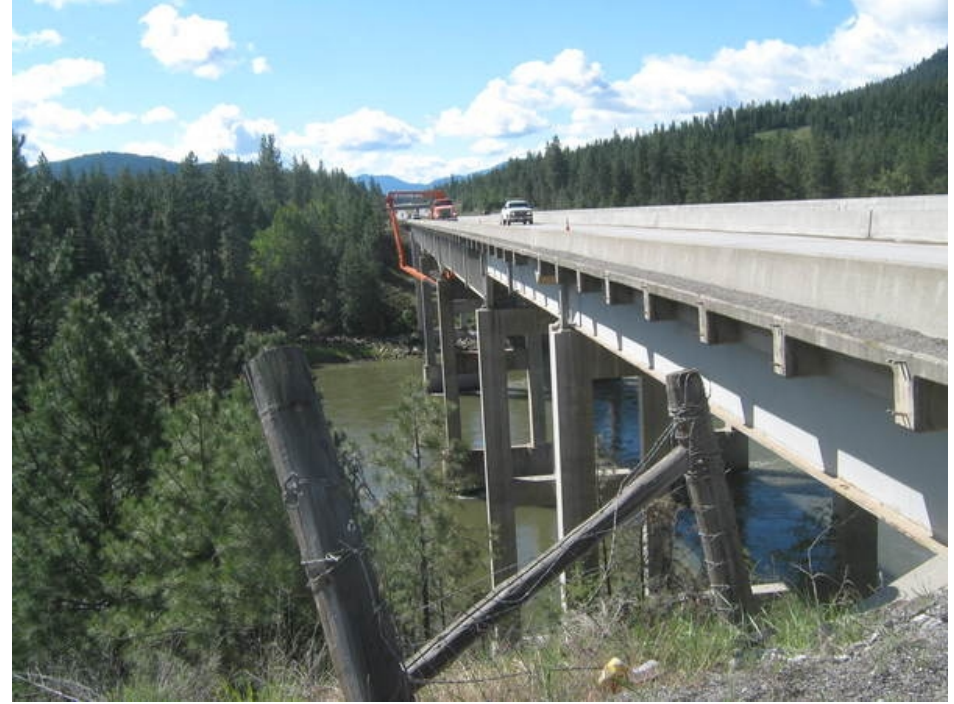
Profile **Notes**

Left side looking Aol.

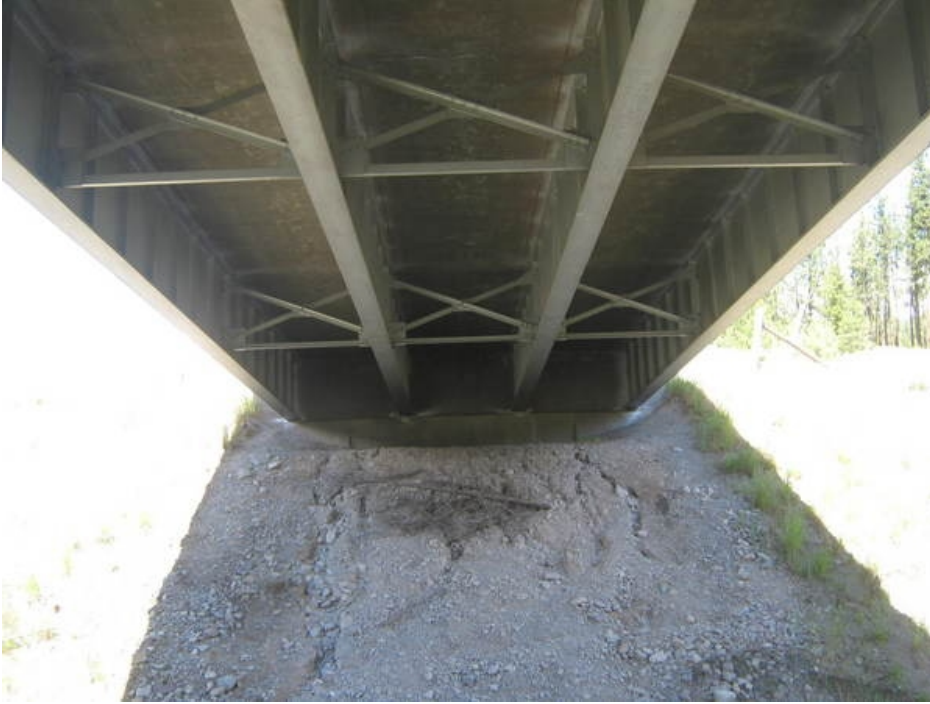
Under bent 2

At bent 2 looking Bol.

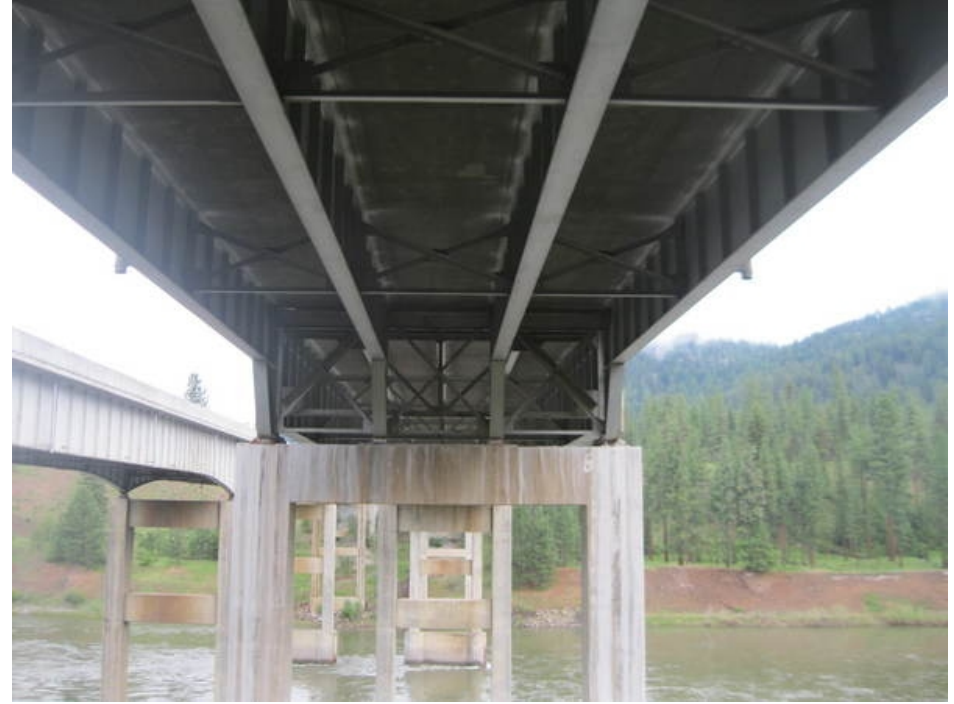
Under Bent 7

At bent 7 looking Bol.

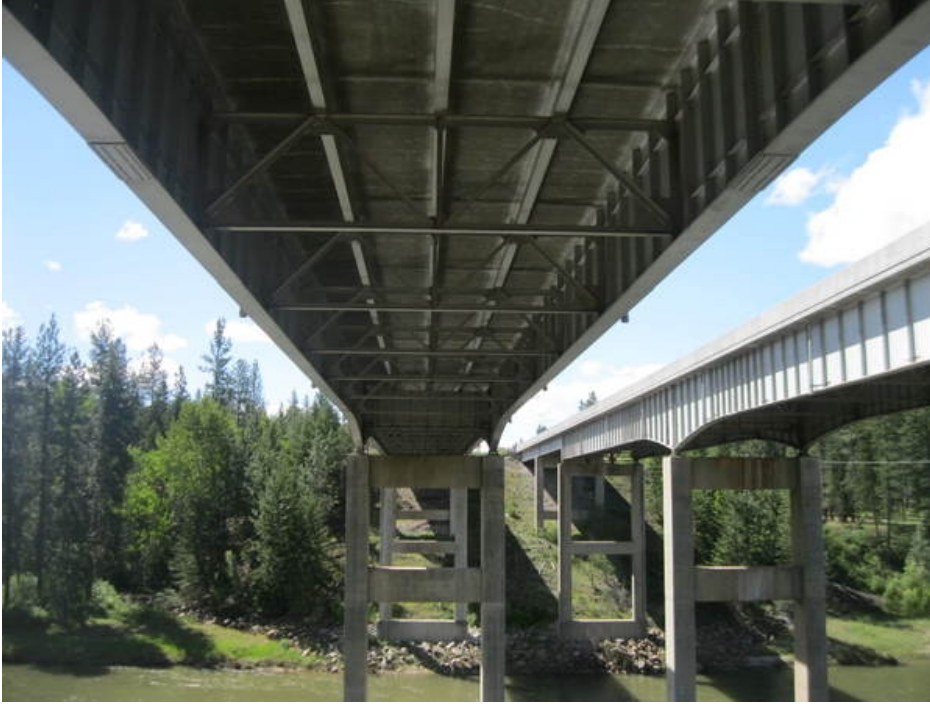
Under bent 4

At bent 4 looking Aol.

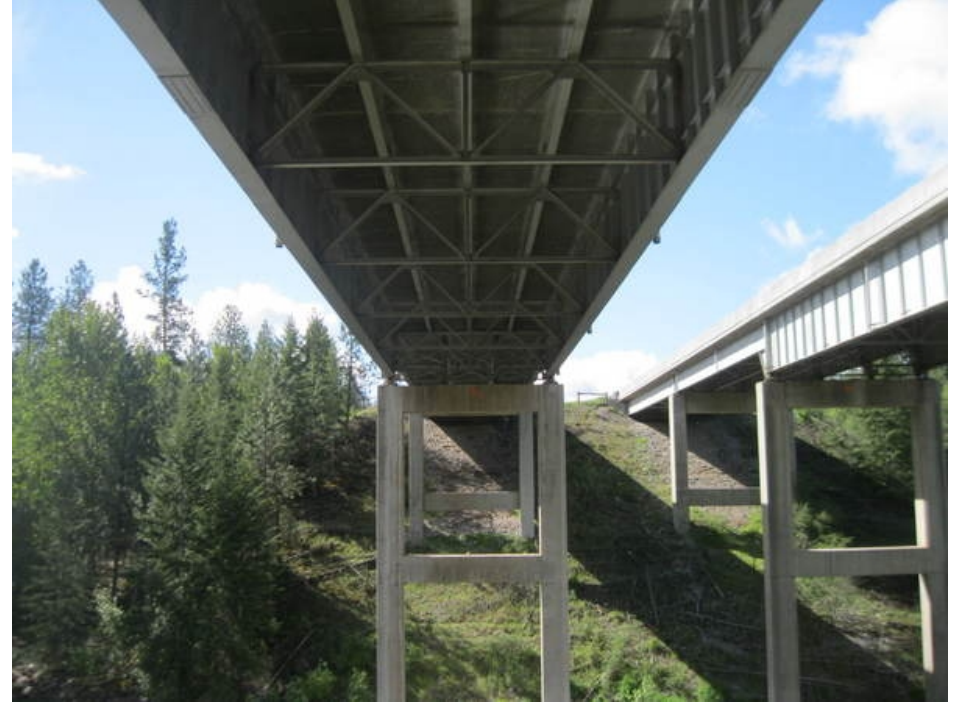
Under bent 5

At bent 5 looking Aol.

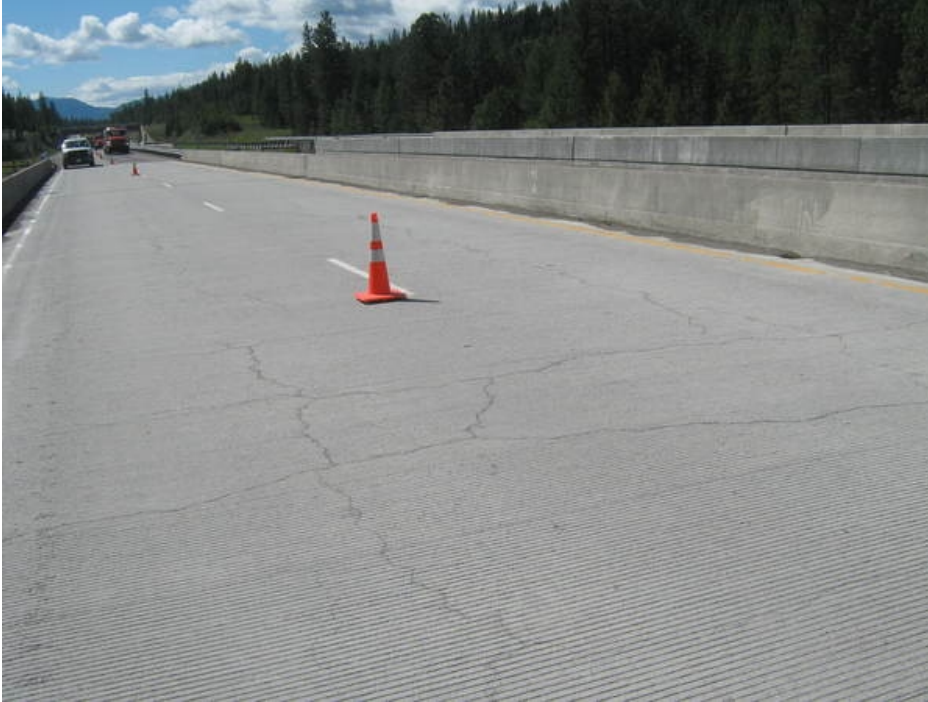
Deck cracking

Main span overlay cracking.

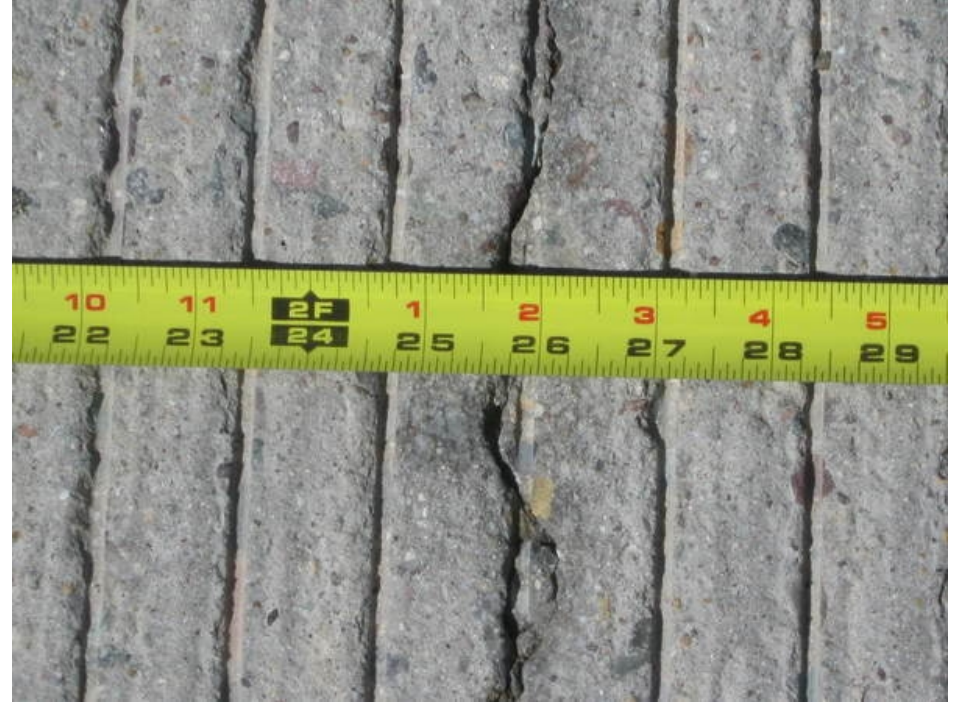
Deck cracking

Main span overlay cracking, typical size.

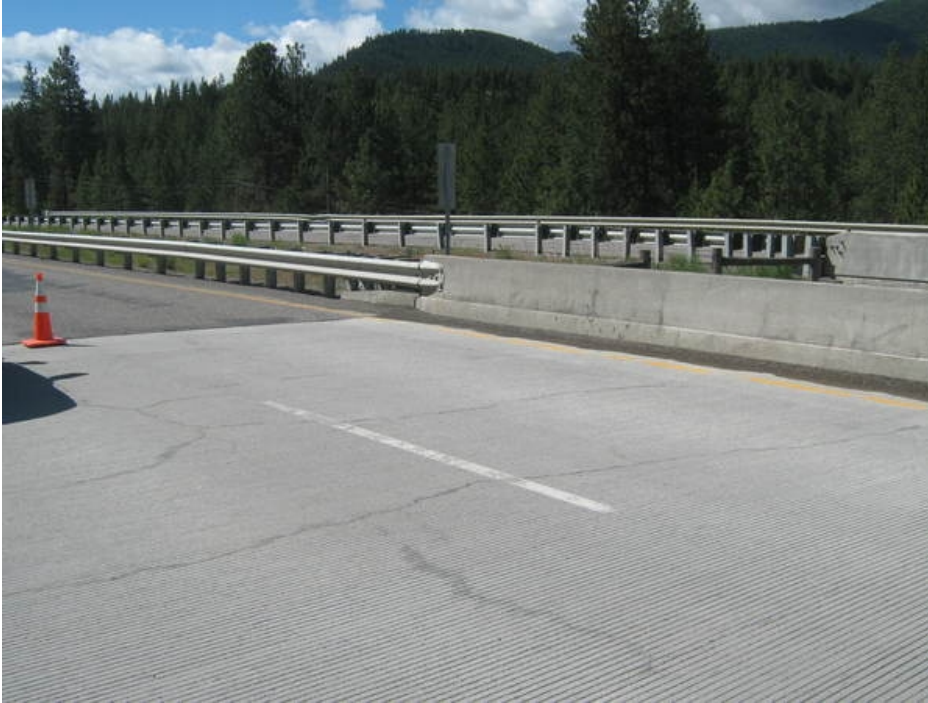
Deck cracking

Approach span overlay cracking.

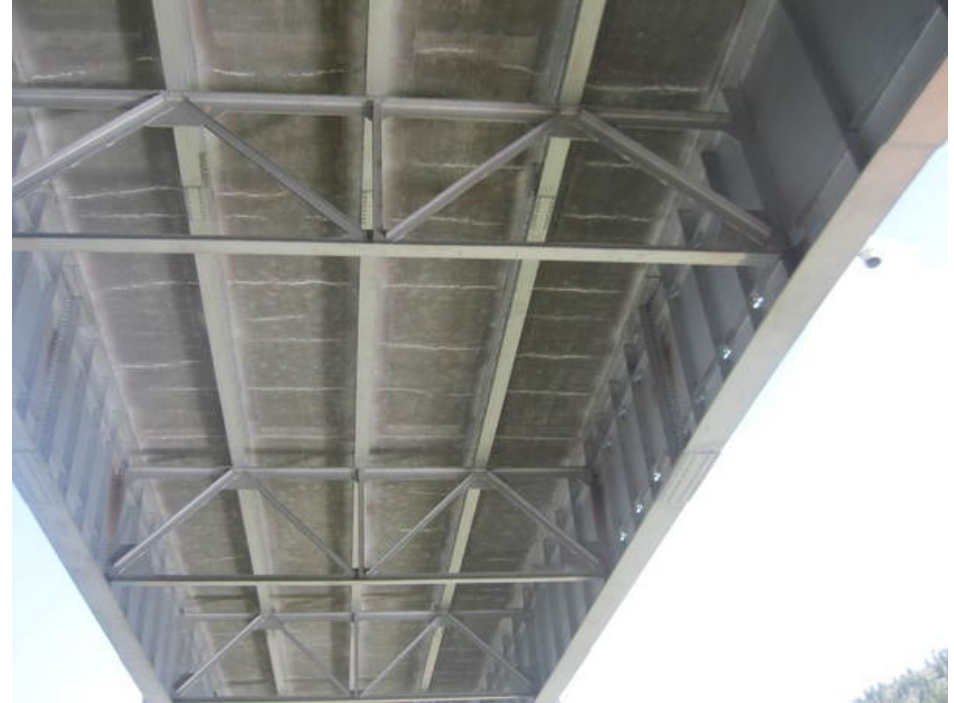
Soffit span 4 mid span, cracking every 6 feet with light efflo.
This is the worst soffit cracking on structure. Approach spans show very little cracking.

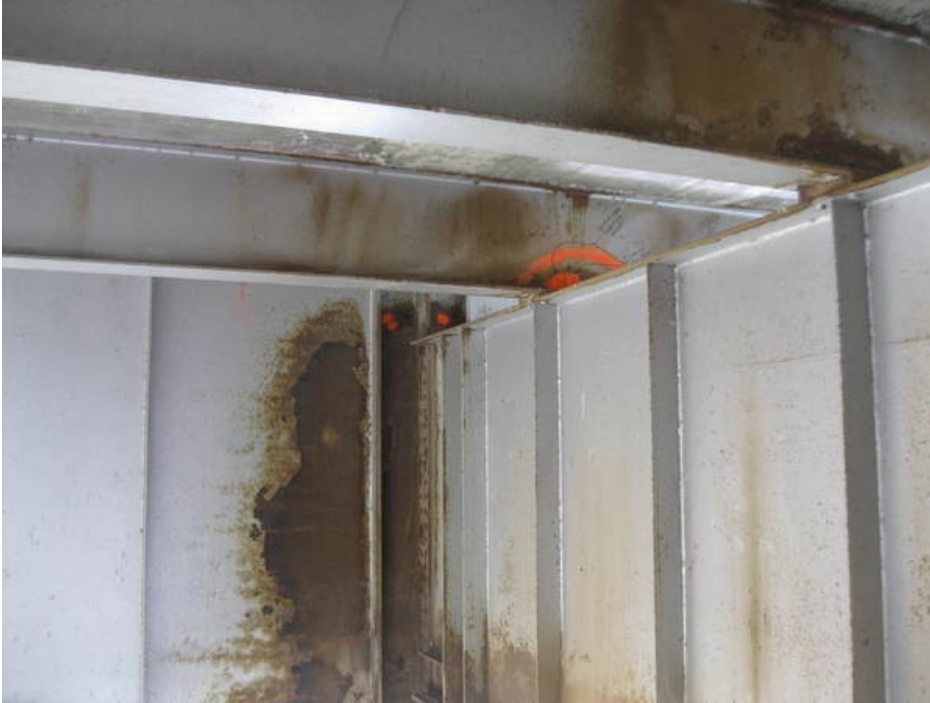
Girder bent 4 Left

Left girder, right side of girder, paint loss, corrosion, 3/32" section loss, Between stiffeners. Also note 5/32" section loss at stringer number 1 in web above bottom flange.

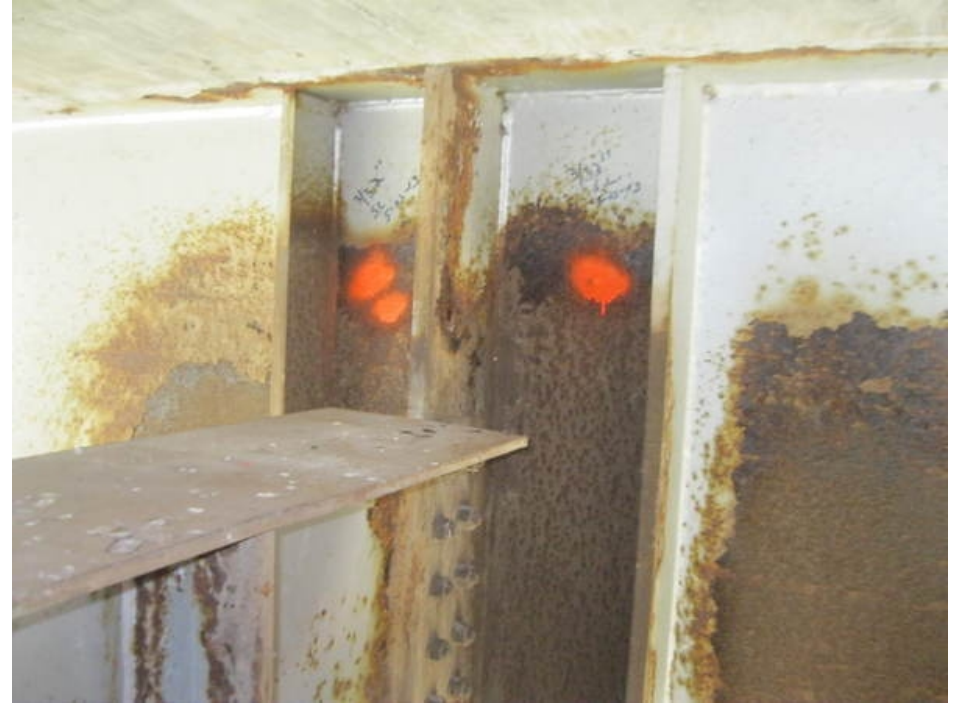
Girder bent 4 left

Same area as previous picture, close up.

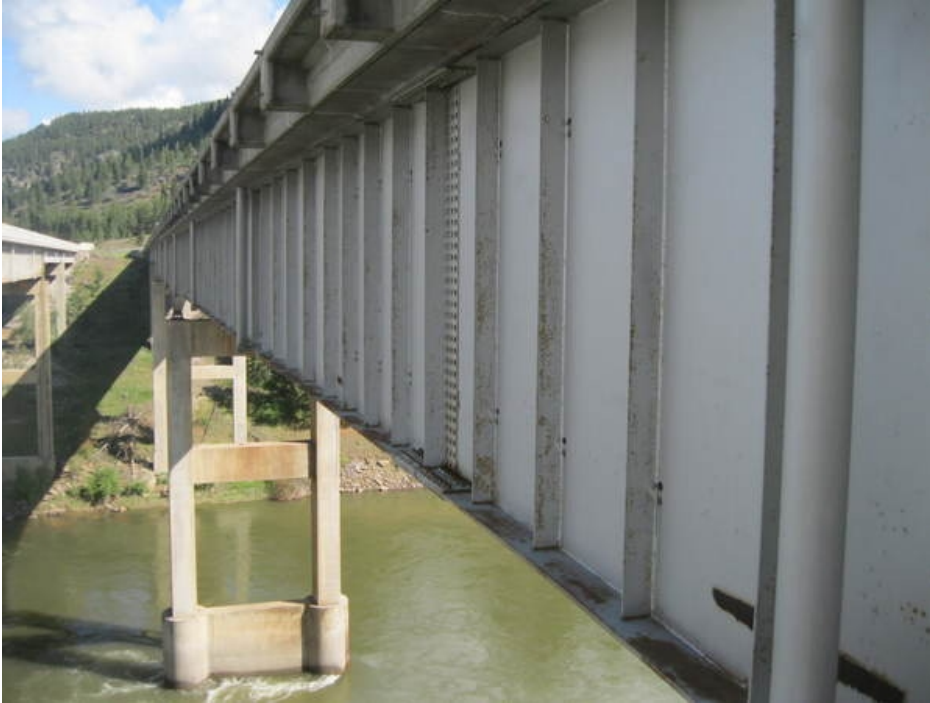
Girder right

Looking Bol from bent 4.

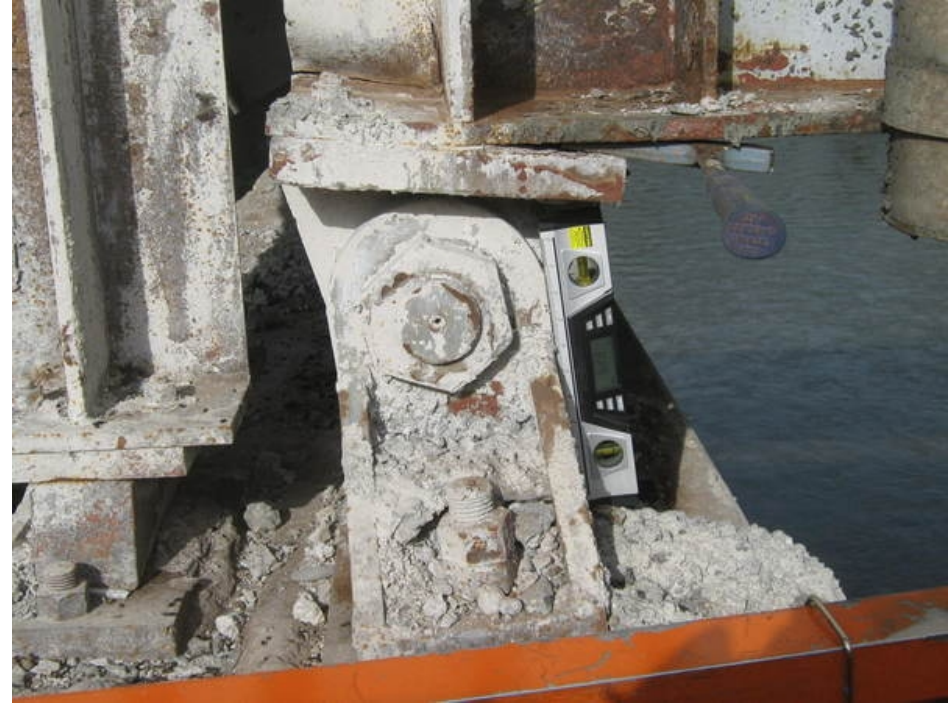
Girder end B 6 Left

The crack just above the weld in the bottom flange has grown and now is to the bearing stiffener. See next photos, will include what I can from past inspections. Also note material on cap.

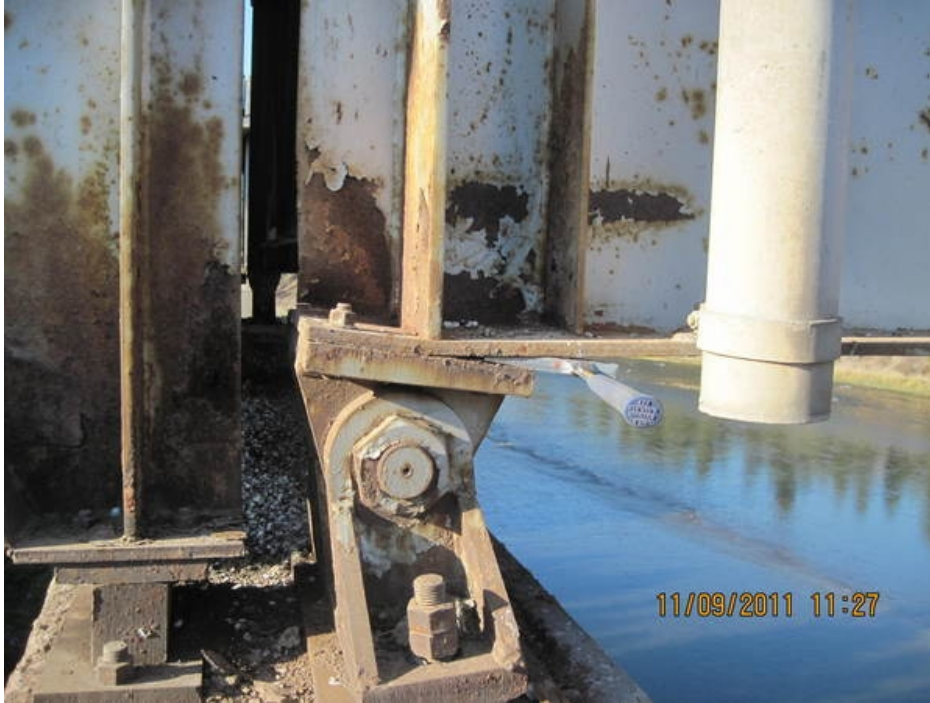
girder b6 left 2011

Same general photo from 2011.

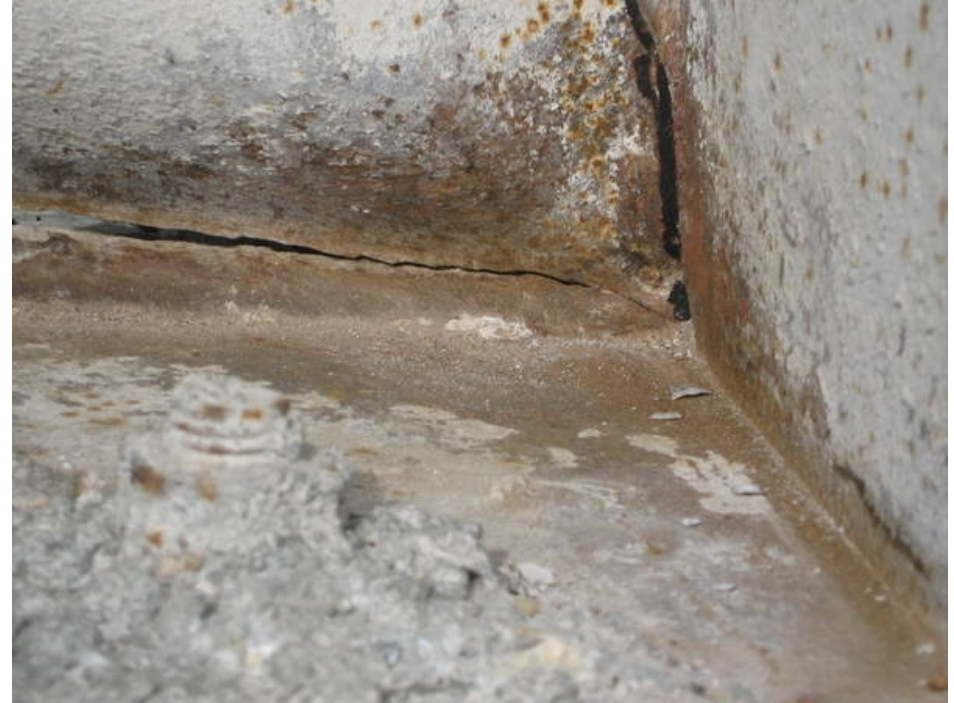
Girder B6 Lt

Close up of crack, bearing stiffener is to the left of picture.

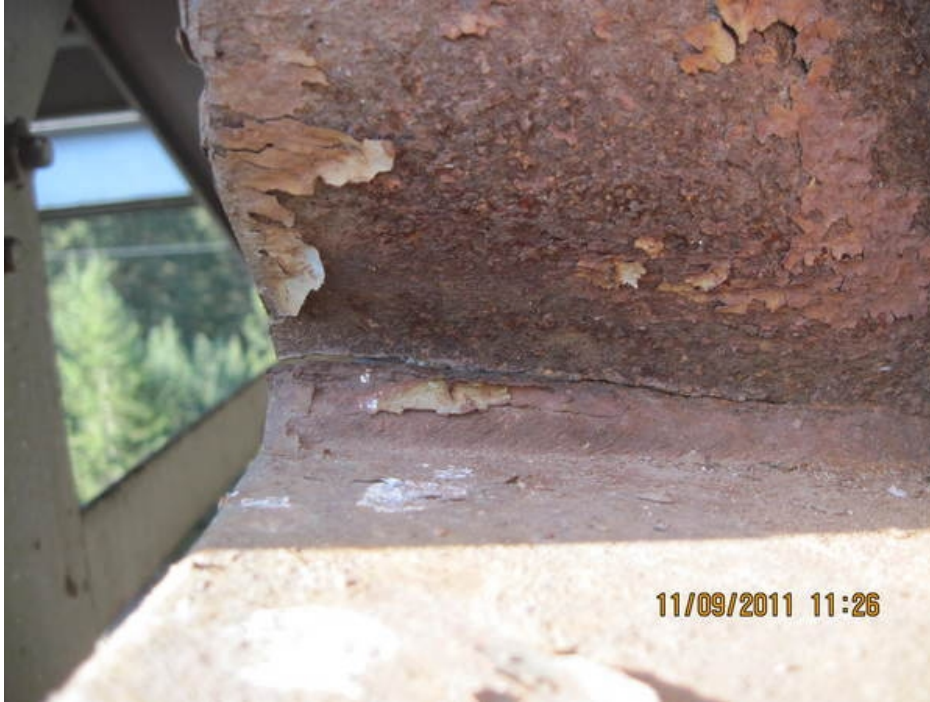
Grider B6 Lt 2011

Same general area as previous picture, note the bearing stiffener is not in this picture(would be just to the left of photo) and crack is not yet to bearing stiffener.

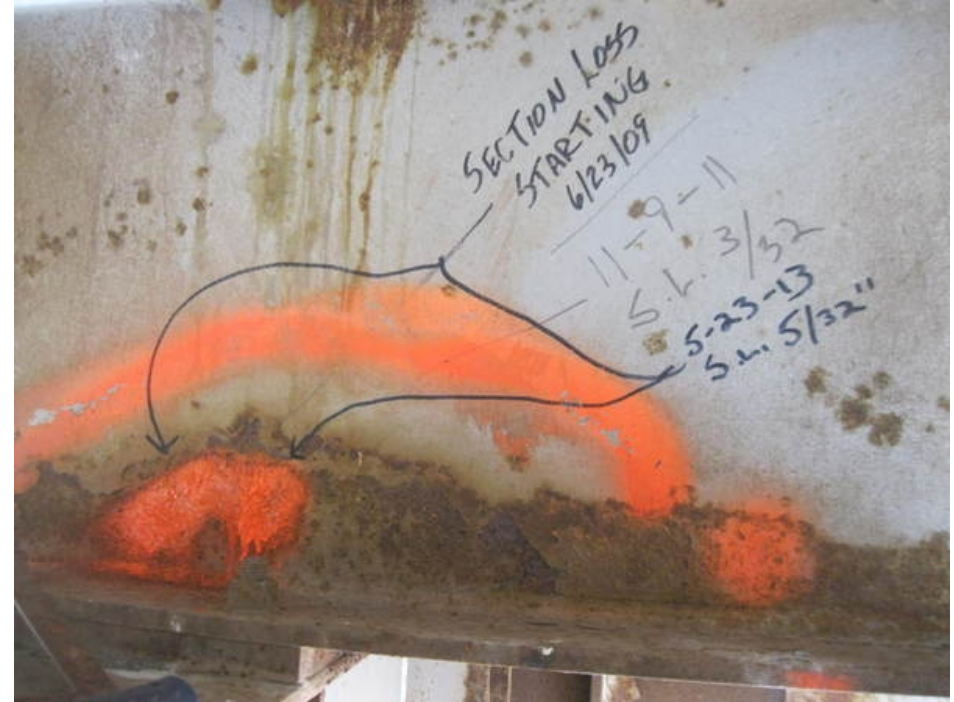
Stringer bent 4

Stringer 1, right side now 5/32" section loss.

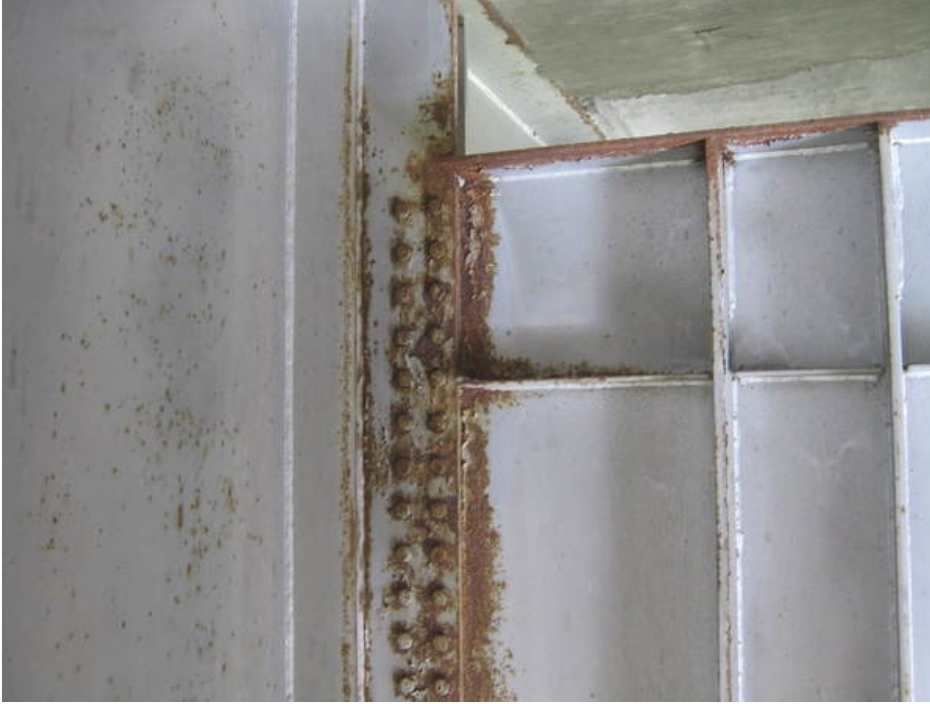
Floor beam Bent 5 rt

Paint loss, freckled rust, pitting/corrosion.

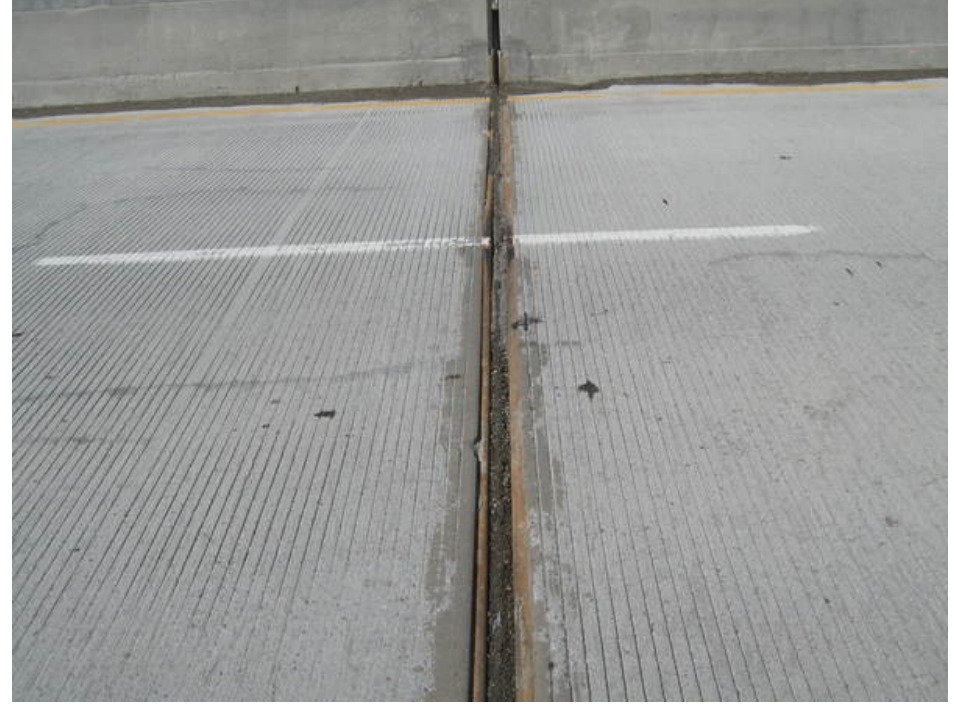
Joint Bent 6

New 2012 Joint bent 6, seal looks ok. Bent 3 similar.

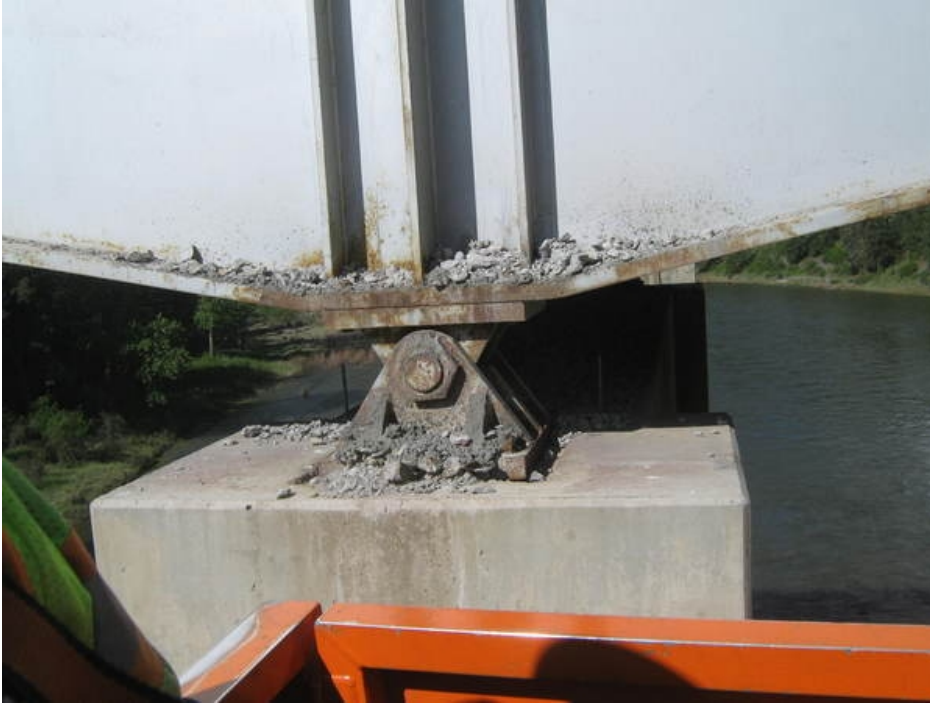
Bearing B 5 Left

Note material on girder and bearing.

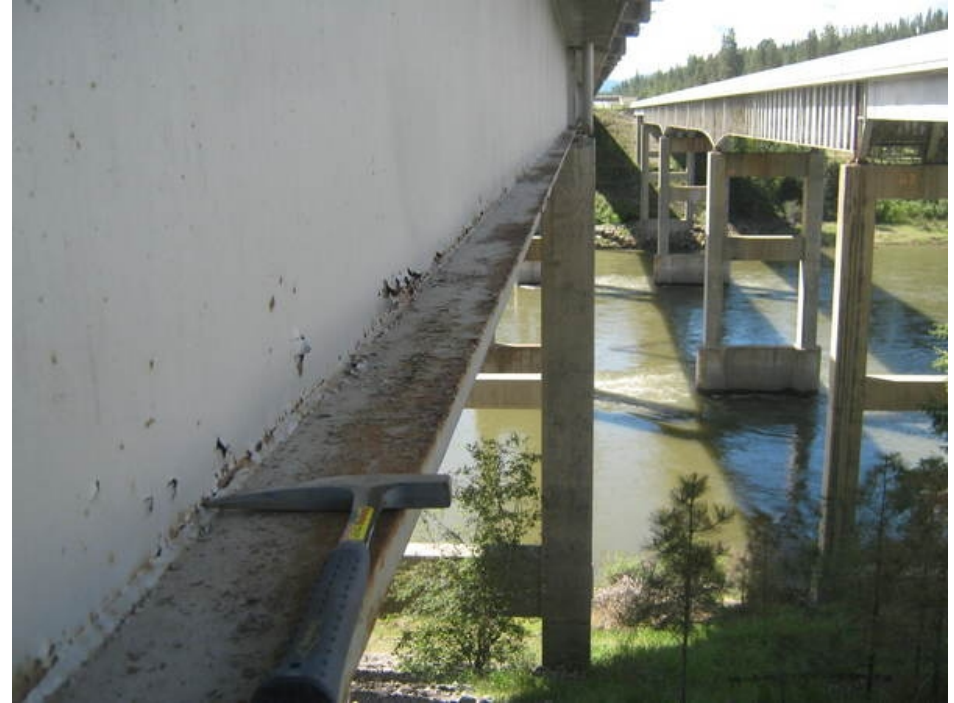
Girder Span 1 Rt ext

Paint loss, freckled rust, pitting/corrosion. Mainly along bottom flange.

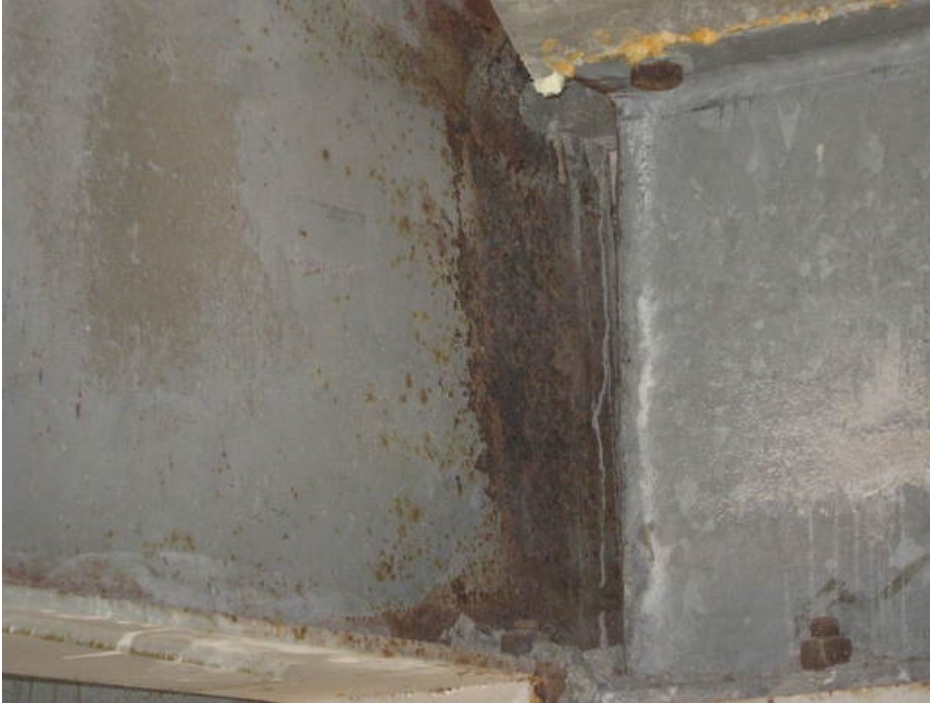
Bent 6 span 6 left

Girder at bent, paint loss freckled rust pitting/corrosion.

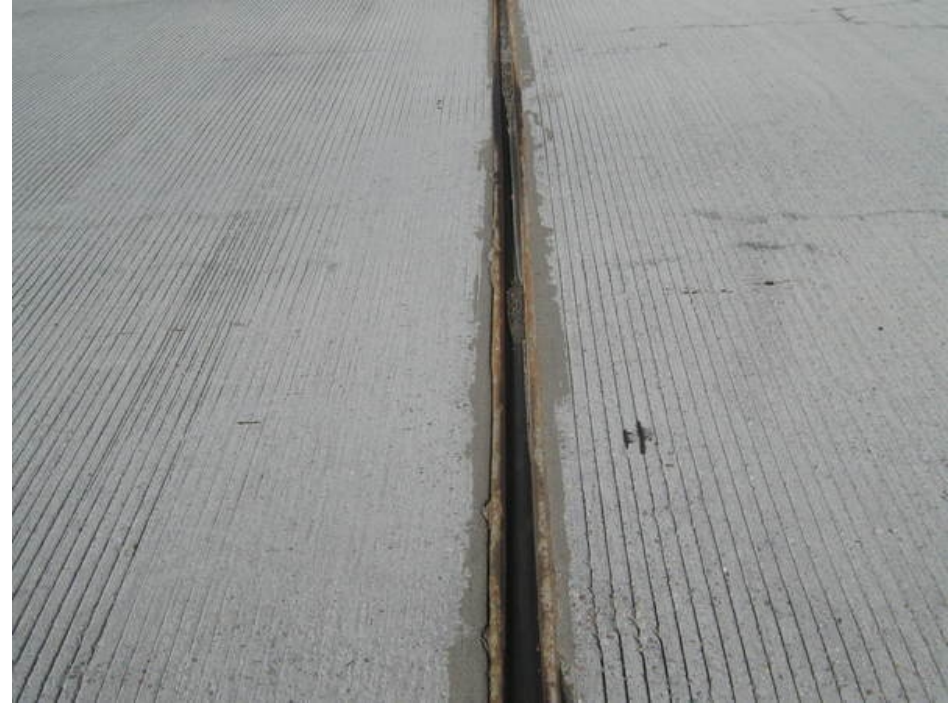
Joint bent 2

New joints (with 2011-2012 reconstruction project-2012 overlay) bent 2 and 7, seals look ok.

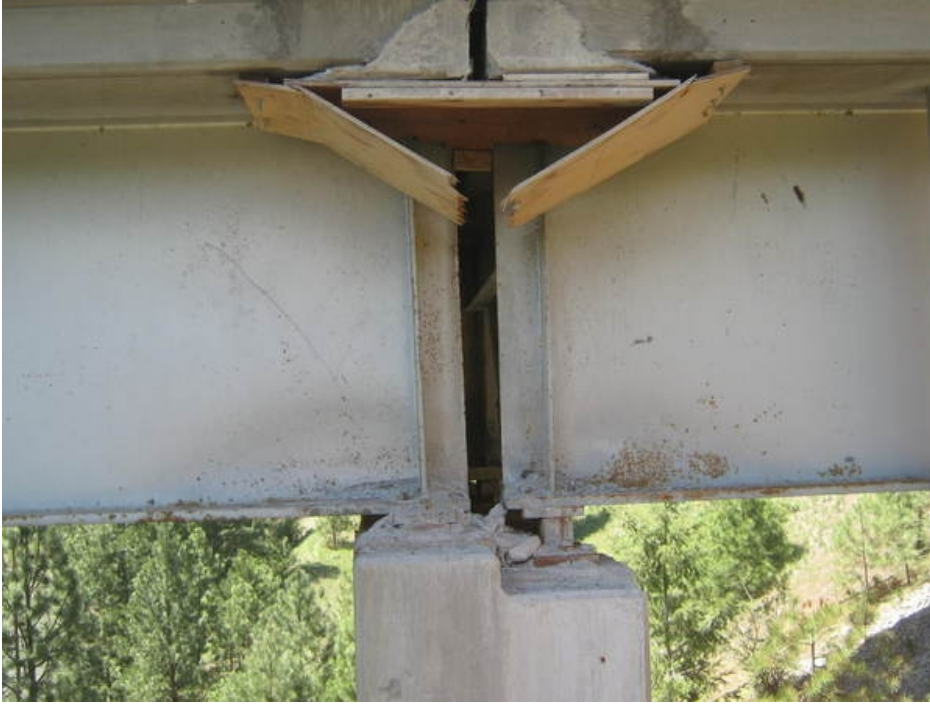
Joint Bent 2 Left

Left side forms left on overhang, note: material on cap, bearings, girders.

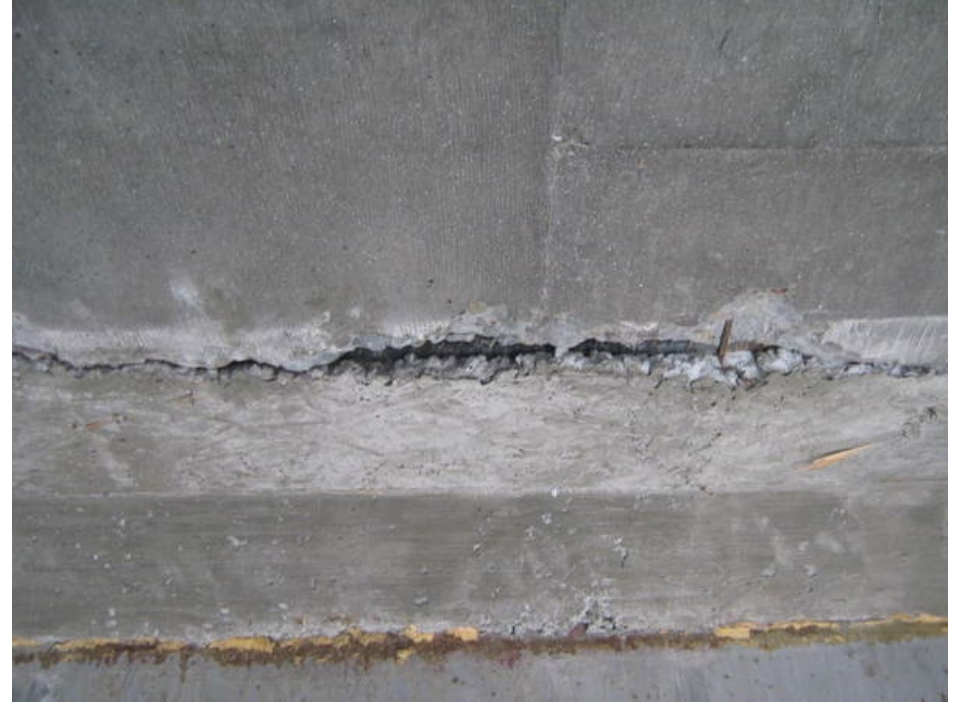
Joint bent 2 span 1

New joint 2012, bent 2 span 1, far right bay, exposed rebar at construction line for new joint.

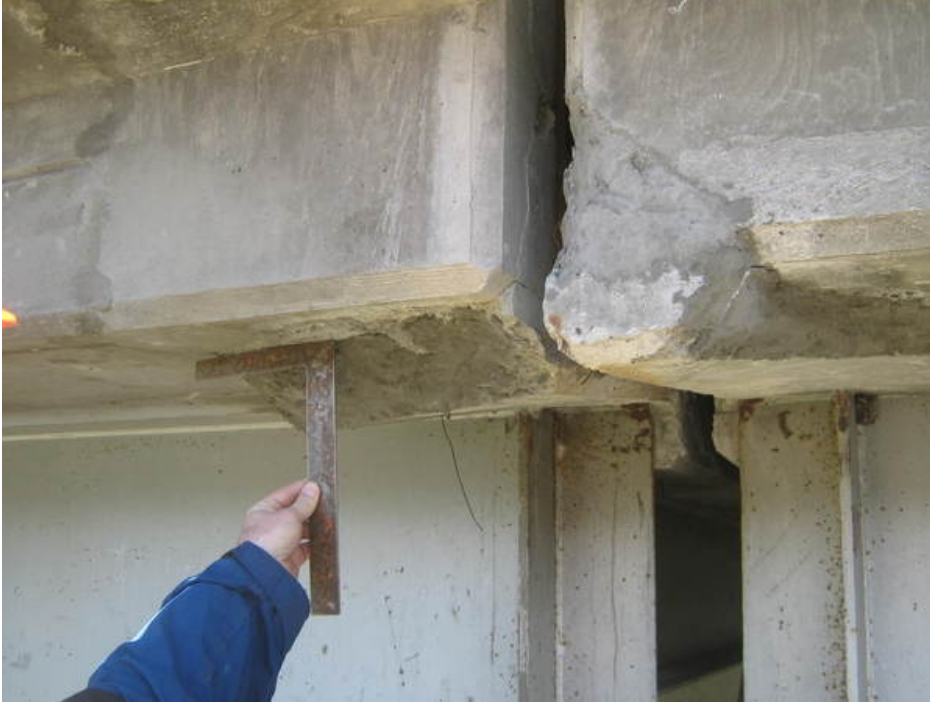
Joint bent 2 right

Over pour? All replaced joints have some forming/over pour, left in place. Bent 2 is the most noteable.

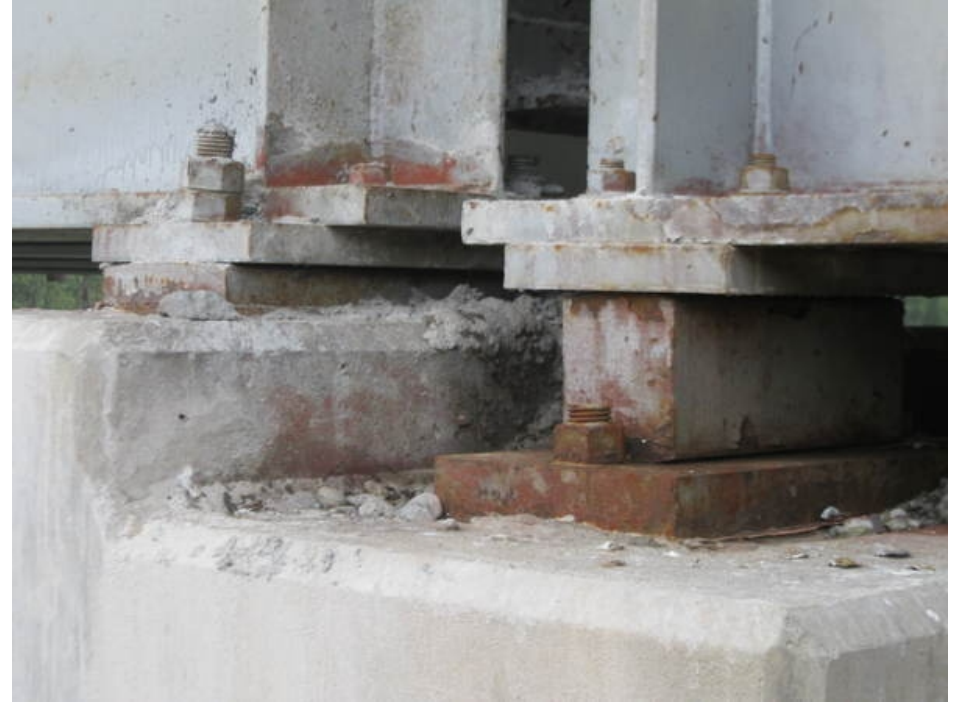
Bearings bent 7 RT

Span 6 to the left of photo, span 7 to the right of photo.

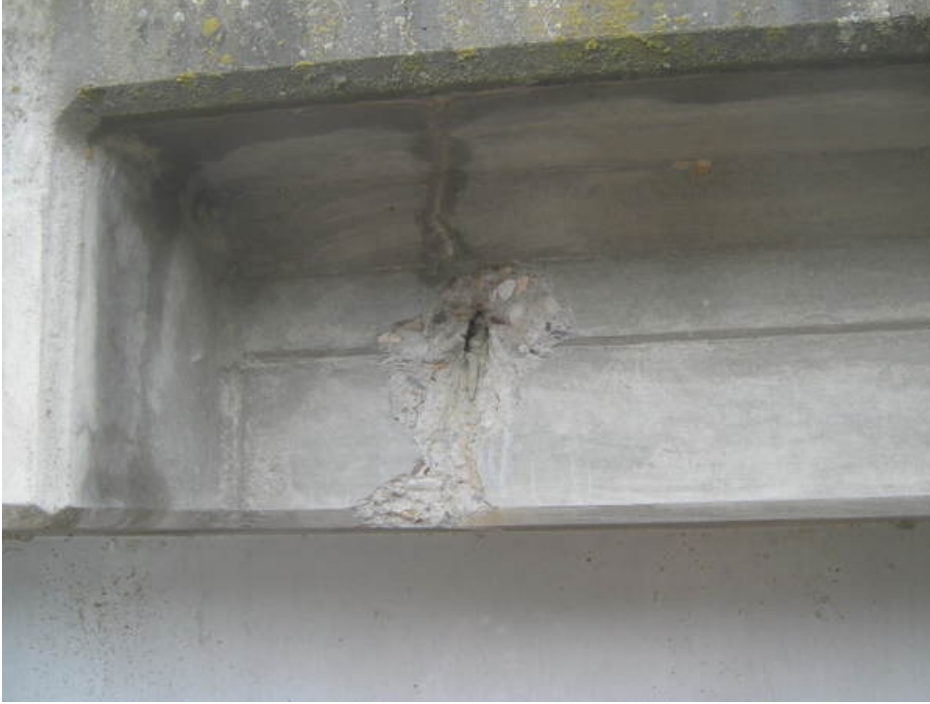
Curb,rail spall

Span 6 right near bent 6.

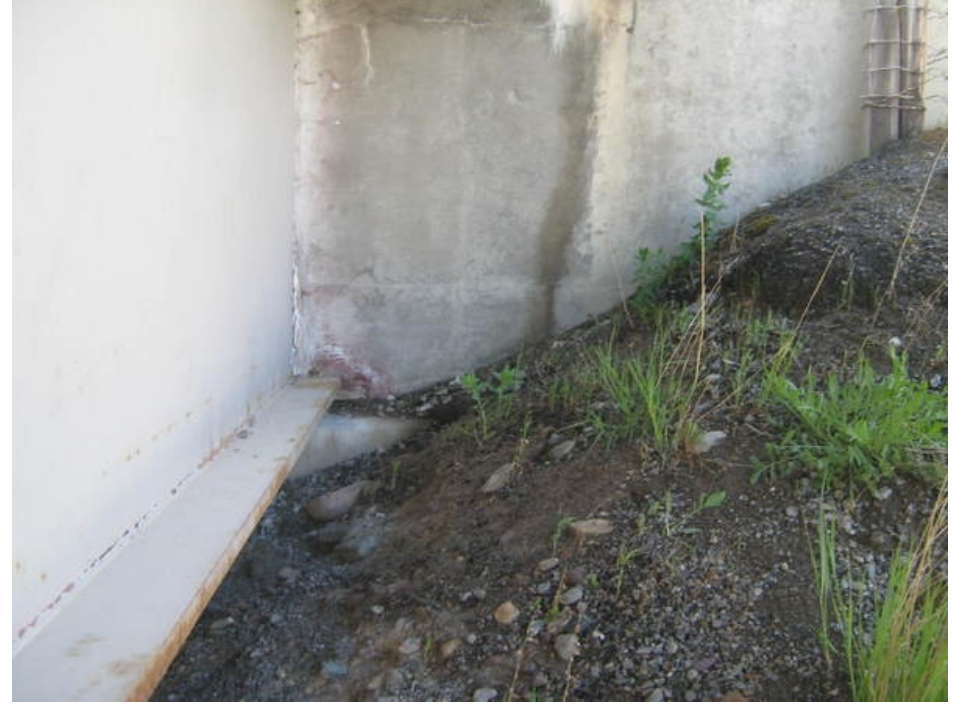
Abutment bent 8 RT

Material on cap left and right bent 1 similar.
